FINAL
QUINAULT ESTATES DRAINAGE INVESTIGATION

Volume I - Text

December 1993

R.W. BECK
AND ASSOCIATES

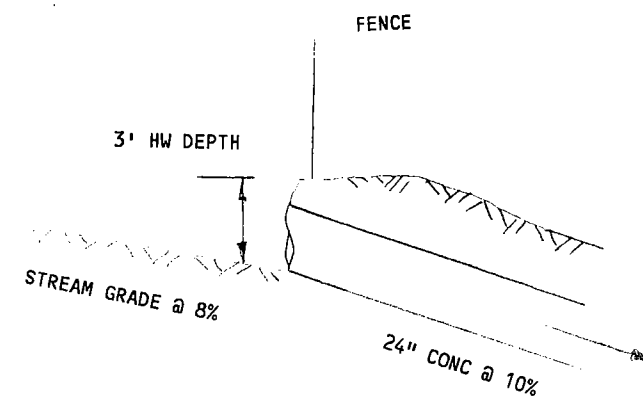
SCHEMATIC PROFILE

1. LARGE VOLUMES OF SEDIMENT AND DEBRIS CAUSES PLUGGING AT INLET
2. INADEQUATE INLET CAPACITY EVEN WITHOUT CONSIDERATION OF SEDIMENT LOAD
($Q_{inlet\ cap} = 22\ cfs$, $Q_{100} = 30\ cfs$)
3. SYSTEM IS PRIVATELY MAINTAINED

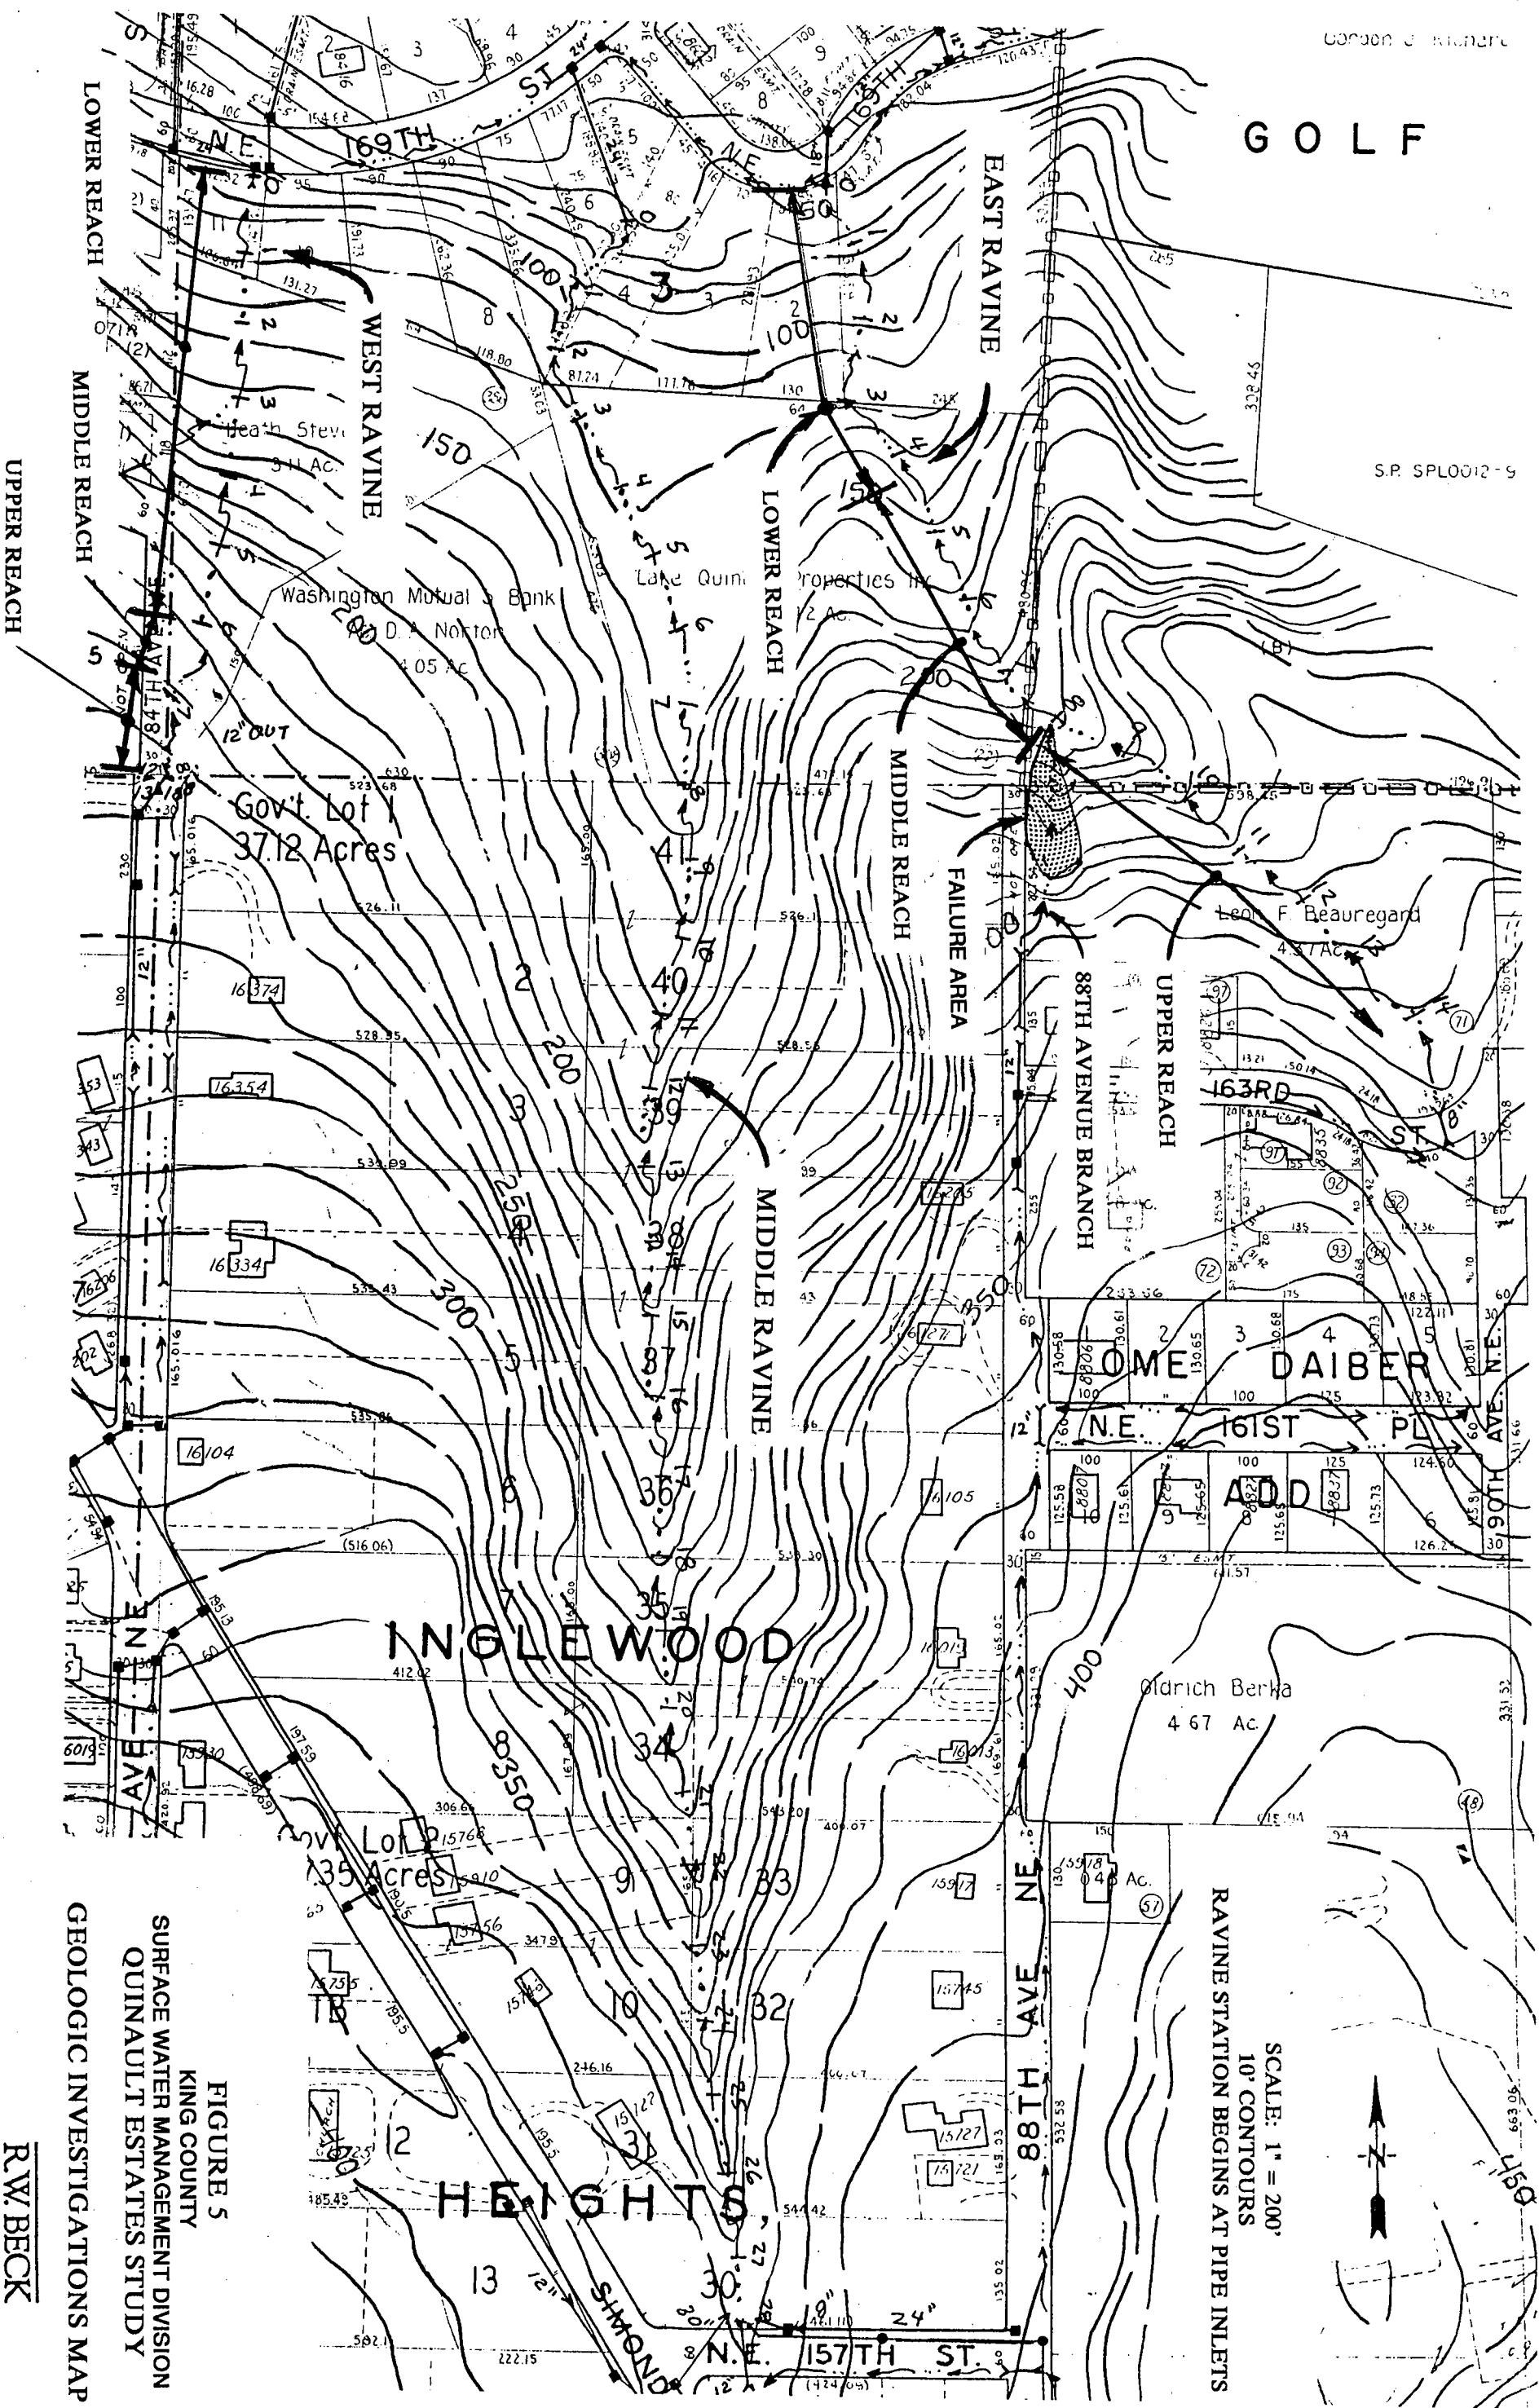
FIGURE 5
KING COUNTY
SURFACE WATER MANAGEMENT DIVISION
QUINAULT ESTATES STUDY
GEOLOGIC INVESTIGATIONS MAP

- a. General Geology. The general characteristics of the area geology were discussed above. Station locations described herein are relative to the pipe inlet in Quinault Estates, with the pipe inlet being station 0+00 and NE 157th Street being station 28+00 (Figure 5 and Photograph 4). A majority of the middle ravine lies within the Transitional Beds. From the Quinault Estates subdivision up to station 2+00 is an alluvial fan. Between station 2+00 and 26+70 the stream is within the Transitional Beds. Between stations 26+70 and 27+60, the in-place material becomes much sandier, suggesting a lens or pocket within the Transitional Beds or Advance Outwash. A 6-foot headcut is visible at station 27+60; upstream of that point, the creek has incised a small channel in the Vashon Till. A profile of the stream is included in Appendix B.

The ravine can be divided into three reaches: the upper reach, the middle reach and the lower reach (Figure 5 and ravine profile in Appendix B.) The upper reach lies 200 linear feet below the pipe outfall at the north end of NE 84th Avenue. The middle reach is a 80-linear-foot section between the upper and lower reaches. The lower reach extends from the middle reach 550 linear feet down to NE 169th Street. The hillslope along the path of the flow has an overall slope of 21 percent.

The existing ravine consists of a natural channel about 1,400 feet long and a 400-foot-long branch which has developed from the outfall of the roadside ditch from 88th Avenue NE (Figure 5). In this report, this will be the 88th Avenue Branch. A schematic profile and photographs of the ravine are shown in Photograph 7.
